Slope Stabilization and Repair Solutions for Local Government Engineers

David Saftner, Principal Investigator

Department of Civil Engineering
University of Minnesota Duluth

Research Project
Final Report 2017-17

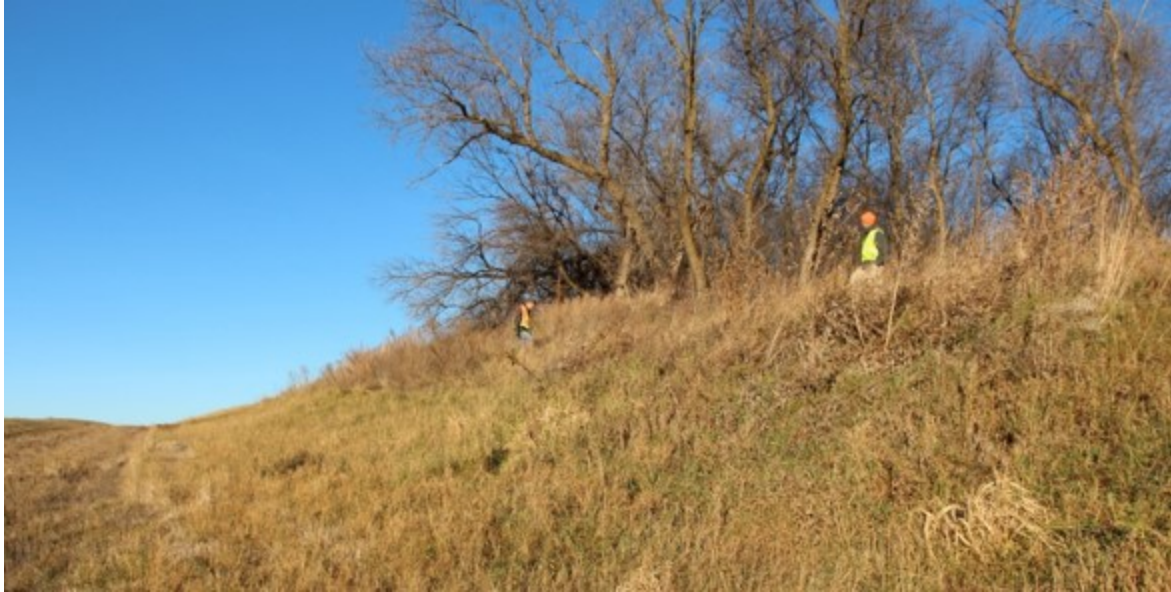
Another advantage of vegetative cover is ease of installation. No specialty equipment is required. Grass seed can be easily placed at low labor cost, and material is readily available. Placing grass seed or other vegetation at the end of a slope repair project is common practice. Vegetative cover also decreases runoff from roadways. A site demonstrating steep slopes held in place with natural vegetative cover is shown in Figure 3.

Figure 3: Vegetative cover stabilizing a slope in Lac Qui Parle County, MN

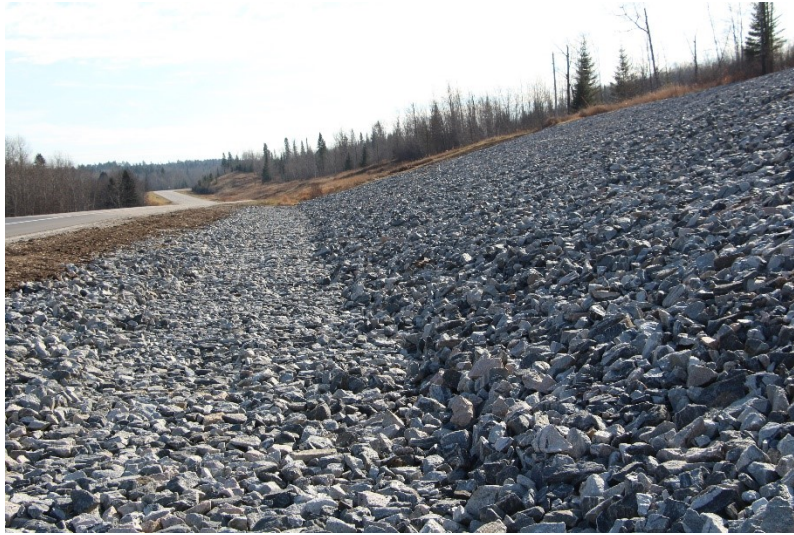
Placing coarse gravel or cobble rip-rap on the slope face can provide surficial protection and limit the effect of erosion, but adds weight. Figure 5 shows a large slope entirely covered with quarried cobble. Rip-rap placement is labor-intensive and generally has a higher cost than earthwork buttressing, but can protect the slope from erosion. Using high-flow concrete (shotcrete) is another option with similar cover advantages. Slope cover methods can add weight and actually decrease global stability; cover is typically an erosion-control method.

Figure 5: Slope covered with rip-rap in St. Louis County, MN

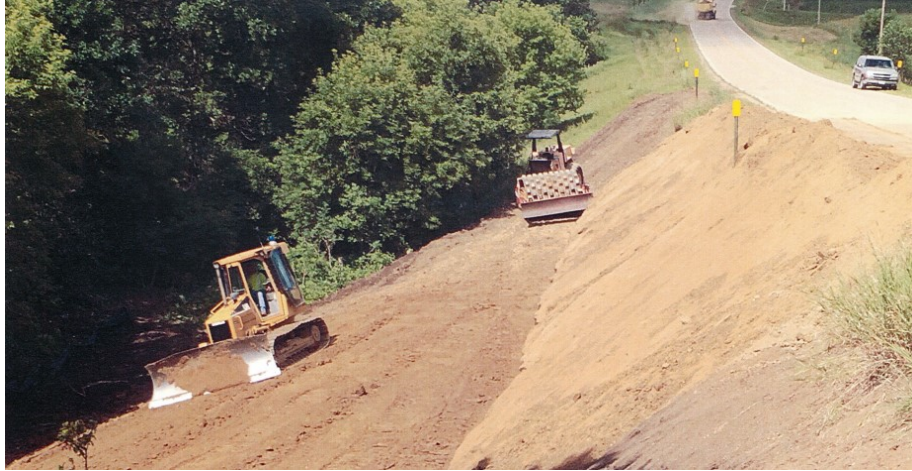
Free draining compacted fill has ideal properties as a slope material. Replacing the potential slide material with this engineered fill minimizes uncertainty in ground conditions and eliminates factors that lead to slope instability. Removing the *in situ* soil and placing fill also allows the design team to control the geometry of the slope. However, material and budget considerations can make this method impractical. In cases where the remove-and-replace option is appropriate, proper fill selection in design improves *in situ* strength and drainage properties. On one such project in Murray County, MN, a convenient source of fill was located near the site. This made the remove-and-replace method feasible. The slope reconstruction process is shown in Figure 6.

Figure 6: Slope reconstruction project in Murray County, MN (from Murray Co. Highway Dept.)

The Murray County site was located on CSAH 22 near Plum Creek, south of Walnut Grove, MN. Slope failure site was identified by evidence of pavement repair. The project team met the county engineer and highway department maintenance supervisor at the site. The slope had been repaired in 2014 using nearby fill, placed and compacted in lifts with geosynthetic reinforcement, as shown earlier in Figure 6. The reconstructed slope is shown in Figure 28.

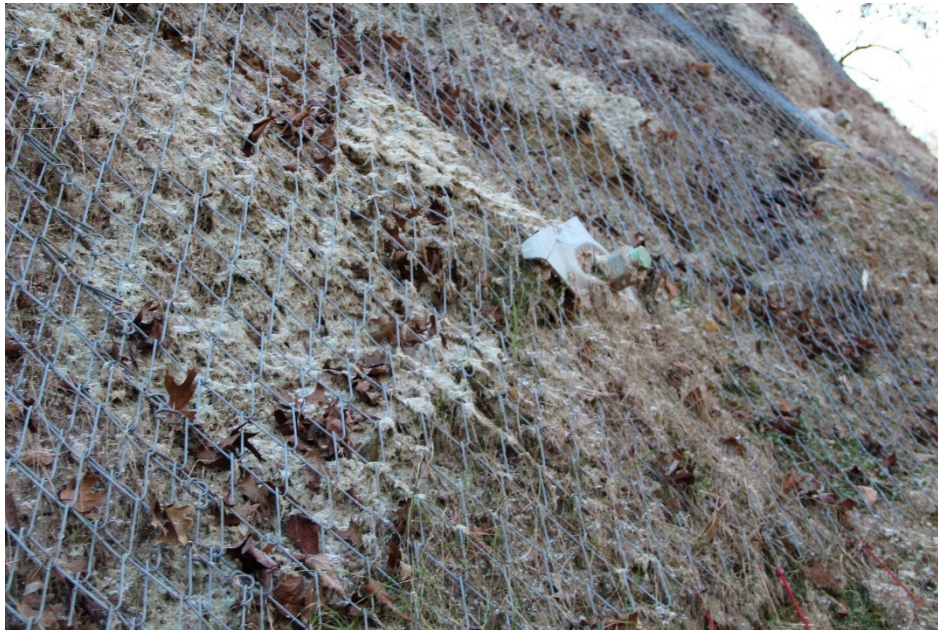
Figure 10: Rock bolts in combination with mesh cover in Washington County, MN

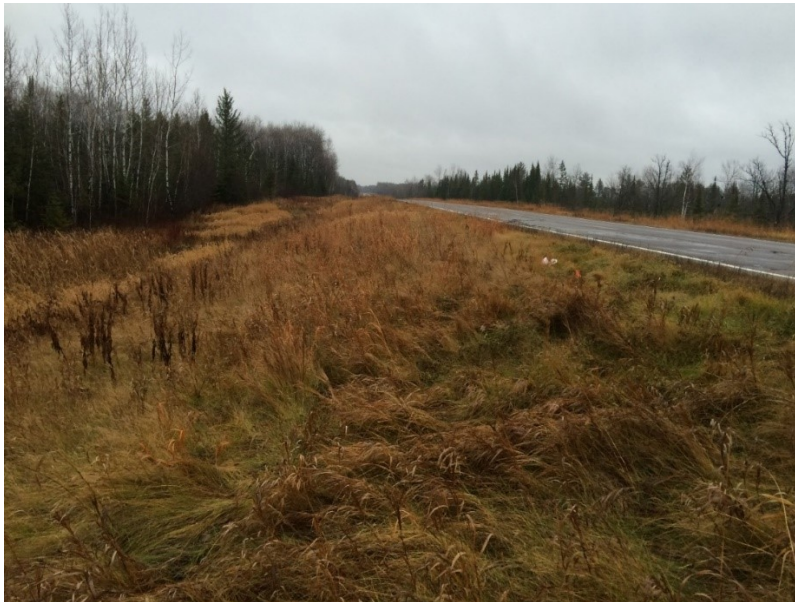
Figure 17: Carlton County site slope

The Carlton County site was located on CSAH 6, approximately 7 miles east of Barnum, MN, near County Road 103. The location was described by the assistant county engineer, and the failure was identified by pavement distress. The site was covered with tall grass, as shown in Figure 17.

In situ material was reddish brown lean clay with sand seams. The sand was brown to light brown and fine to medium-grained. The material under the embankment was borrow fill. *In situ* testing indicated average S_u values of 1.25 to 1.5 tsf. Correlated N_{60} values were approximately 2 blows per foot. No groundwater was encountered during sampling. Ojakangas (2009) and Hobbs and Goeble (1982) identified the region's geology as glacial drift. The observed fine-grained soil is consisted with glacial deposits. No slope stabilization attempts were observed.

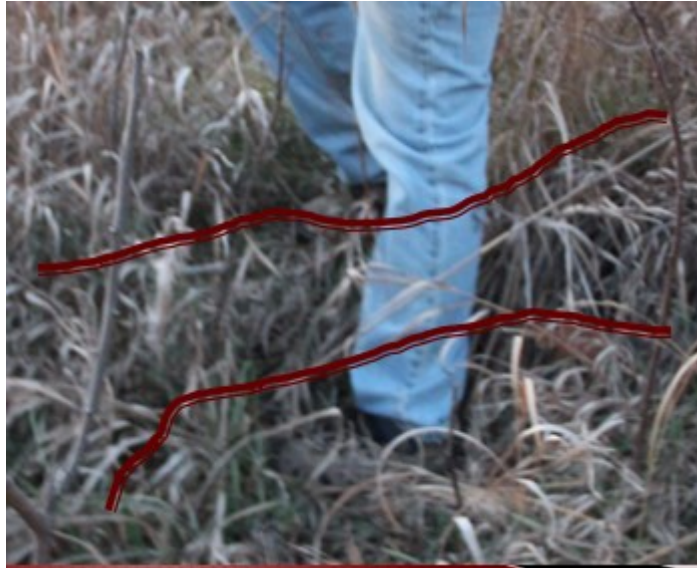
The Fillmore County site was located on CSAH 5, approximately 5 miles southwest of Chatfield, MN. The county engineer identified the location in the initial survey. The site was characterized by significant pavement distress, as illustrated in Figure 19. The Middle Branch Root River was near to toe of the slope. Investigators noted a large failure with clear scarp lines, characteristic of rotational slide failure, leaving vertical faces 1.5 to 2 feet tall (Figure 20 and Figure 21). The site was covered by tall grass. Topsoil extended 6 to 12 inches below the surface.

The soil was brown, fine-grained silty sand. Researchers conducted field sampling and *in situ* testing in an area inside and outside the failure region. S_u values ranged from 1.25 to 1.75 tsf. DCP testing results indicated that the top several blows (20 to 30 cm) had a relatively low resistance to penetration, with deeper material having a higher resistance. The soil's correlated N_{60} values were approximately 4 to 5 blows per foot. The geology of the site was weathered material on bedrock (Ojakangas, 2009; Hobbs & Goebel, 1982), consistent with soil observed. With the toe of the slope near a stream, the researchers identified groundwater and drainage conditions as a concern for this slope. As with several other slopes studied, the side of the road near a stream is failing, illustrating the importance of drainage. The field investigators did not observe any slope stabilization methods in place.

Figure 21: Scarp face at edge of failure at Fillmore County site

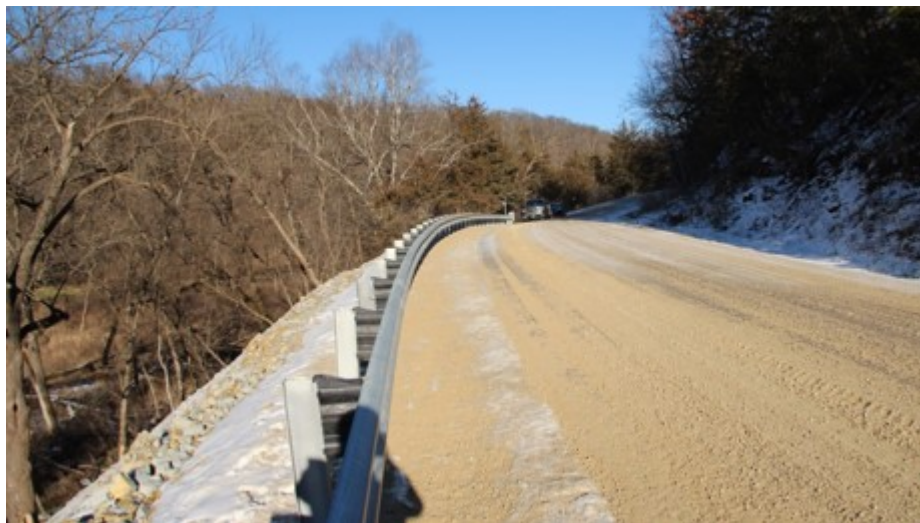
Soil was sampled on the slope above the roadway, shown in Figure 23, which was original slope material. Soil sampled was brown to dark brown silty sand. DCP testing was not performed at this site. Ojakangas (2009) and Hobbs and Goebel (1982) identified the geology of the region as weathered material on bedrock. The slope was located near a stream, providing an indication of groundwater depth. The immediate proximity of the toe of the slope to a stream indicated that groundwater is a concern for this site.

Figure 23: CSAH 19 Houston County site with steep uphill and downhill embankments

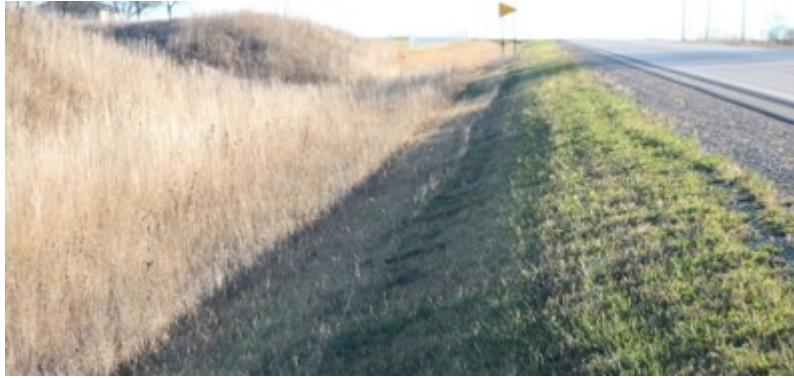
The Lac qui Parle County site was located on CSAH 20 between the Minnesota River and Lac qui Parle Village. The county engineer met the project team onsite to describe erosion issues in the area. There was minimal to no evidence of slope failure affecting the roadway, as shown in Figure 25, but there was

Figure 25: Steep backslopes along CSAH 20 in Lac Qui Parle County

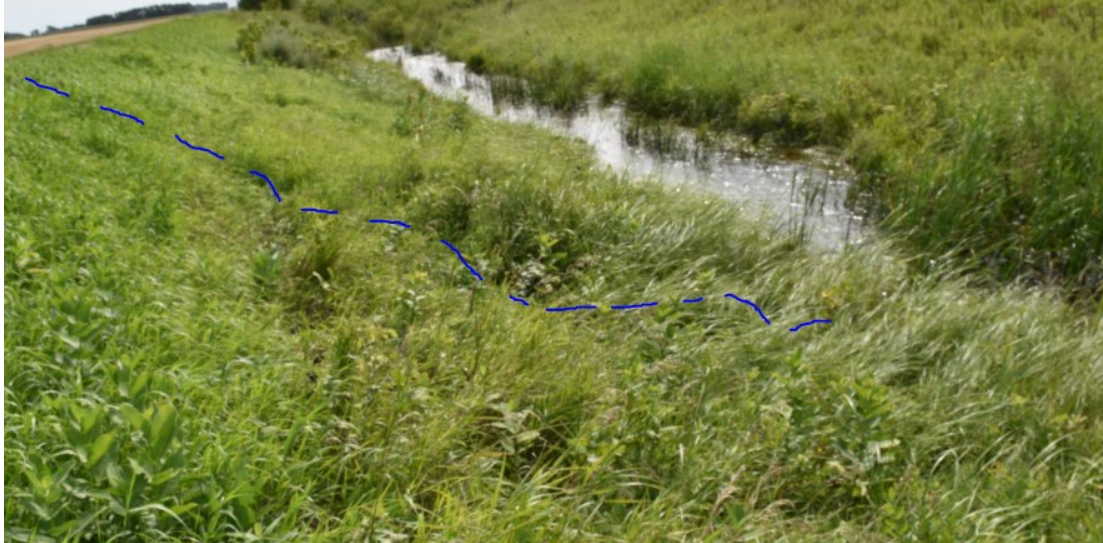
The Marshall County site was located on 280th St. NW, approximately 7 miles northwest of Warren, MN. The County Engineer identified the location in the initial survey. The site was characterized by multiple small failures down the slope. A drainage ditch with standing water was located near the toe of the slope. The site was covered by tall grass, making visible observation of the failure difficult from a distance. Topsoil extended 6 to 12 inches below the surface. The site is shown in Figure 27.

Figure 27: Marshall County site slope

Soil appeared to be gray to dark gray clay with trace sand. DCP testing indicated the soil's correlated N_{60} values were approximately 3 to 4 blows per foot. The geology of the site was sediment from Glacial Lake Agassiz (Ojakangas, 2009; Hobbs & Goebel, 1982); soil at the site was representative of glacial sediment. Given the toe of the slope was near standing water, the researchers identified groundwater and drainage conditions as a concern. As with other slopes studied, the embankment near a water source was failing, illustrating the importance of drainage. The presence of groundwater, frost susceptible soil, and cold weather made this site a good example of how the freeze-thaw cycle can affect slope stability and lead to creep failure. Researchers did not observe any slope stabilization methods.

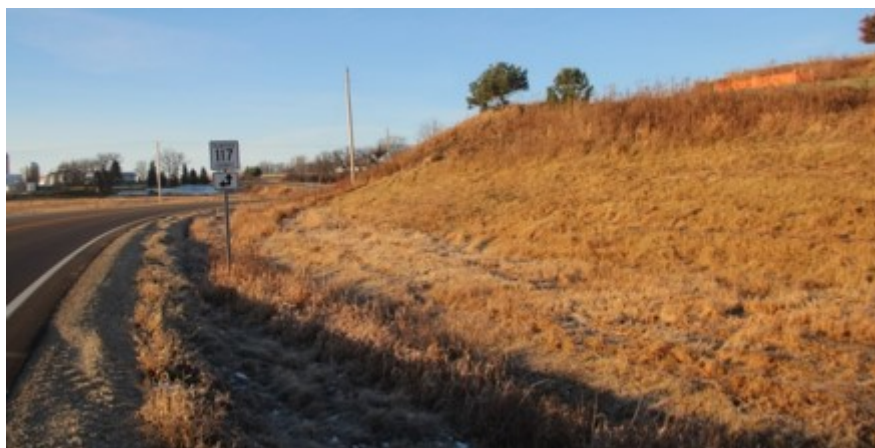
The Olmsted County site, pictured in Figure 29, was located on CSAH 15 at County Road 117, west of Rochester, MN. The site was characterized by a steep backslope, leading up to a private yard. The slope exhibited clear failure marks, shown in Figure 30. The failure in the backslope did not appear to affect the roadway, or public right-of-way. The site was identified in the survey by the county maintenance engineer. The slope was covered by thick grass and brush, with some small trees at the top of the slope. Roots were evident in hand sampling, and topsoil extended to a depth of approximately one foot.

Figure 29: Olmsted County site slope

Observed soil was light brown silty sand. Sampling and *in situ* testing were conducted both inside and outside of the visible failure area. Results of DCP testing indicated roughly the top half of the DCP depth had low resistance to penetration, while the second half of the test depth exhibited more resistance. The failed soil had a correlated average N_{60} value of 2 blows per foot, and the soil that did not exhibit visible failure had an average N_{60} value of 3 blows per foot. Ojakangas (2009) and Hobbs and Goebel (1982) described the geology of the region as glacial drift.

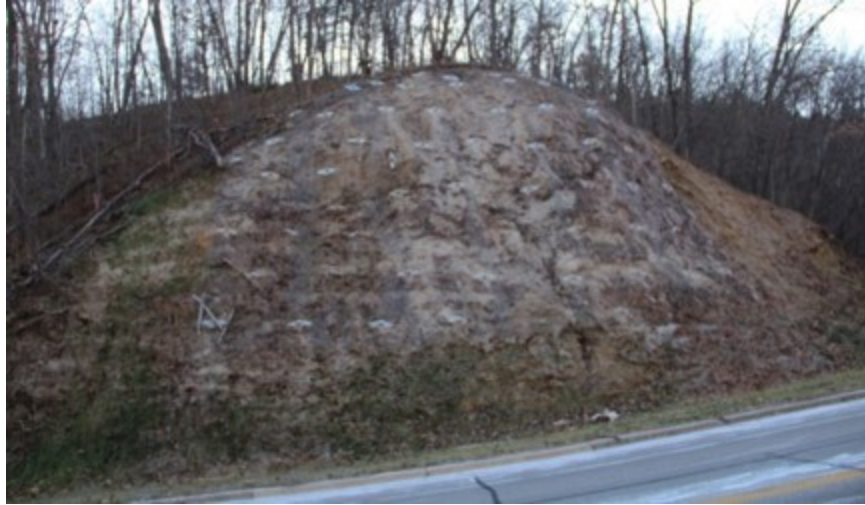
The Washington County site was located on CSAH 21, approximately one mile south of Afton, MN. The site was identified by the assistant county engineer in the initial survey. While some pavement repair was apparent at the site, the main site identification was wire mesh and rock anchors covering the slope. The slope was very steep, and large portions of exposed rock were visible from the road, as shown in Figure 36. The team was provided two geotechnical reports from the slope project. The main face of the slope was covered with wire mesh and rock bolts, as pictured in Figure 37. This site provides examples of using surface cover (i.e. wire mesh) and reinforcing structures (i.e. rock bolts) to stabilize slopes.

Figure 36: Washington County site slope

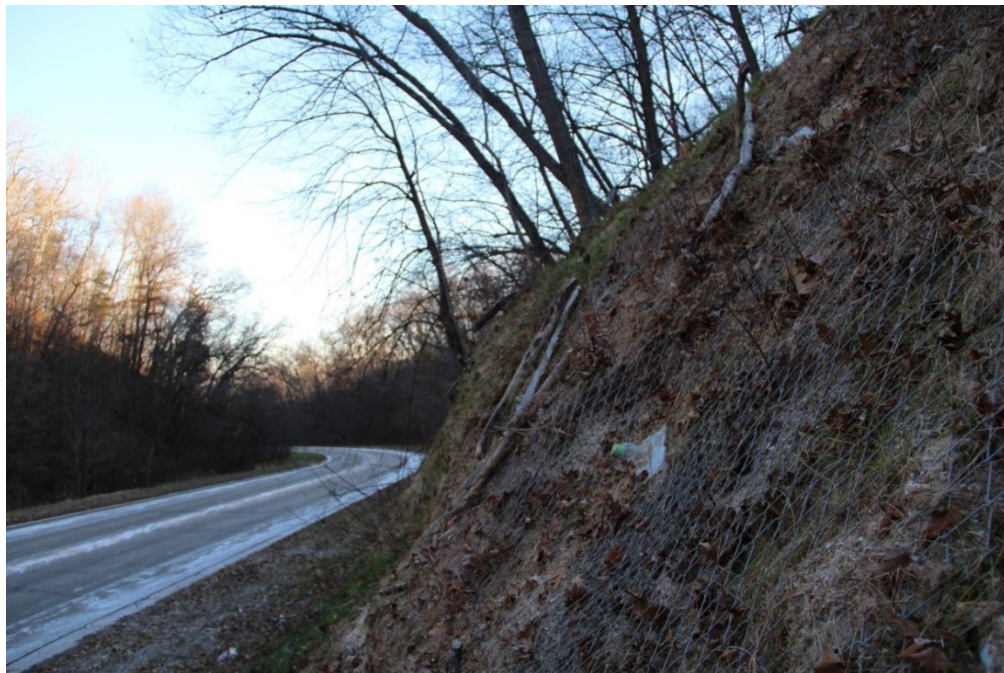
Figure 37: Wire mesh and rock bolt cover at Washington Co. site

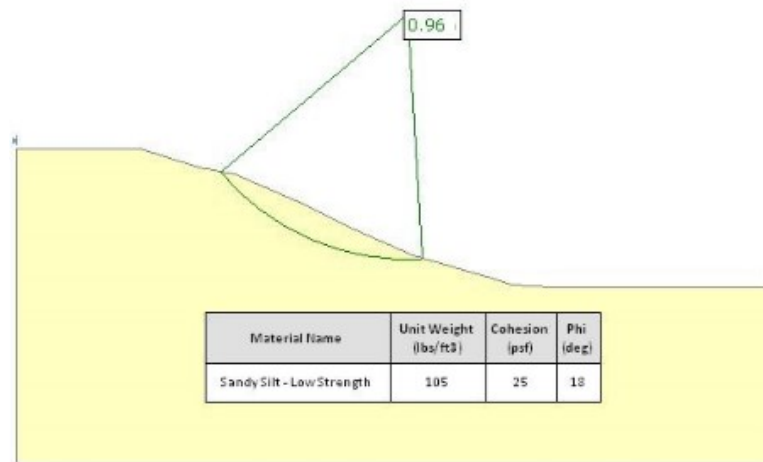
noted in the field. Figure 38 shows a failure validation example (from the Olmsted County site) with strength properties corresponding to poor compaction.

Figure 38: Example failure validation, output matches observed slope failure

The example in Figure 38 shows the geometry of a site where researchers observed a clear rotational slide. With a representation of *in situ* conditions, authors could note the effect of each method for the site.

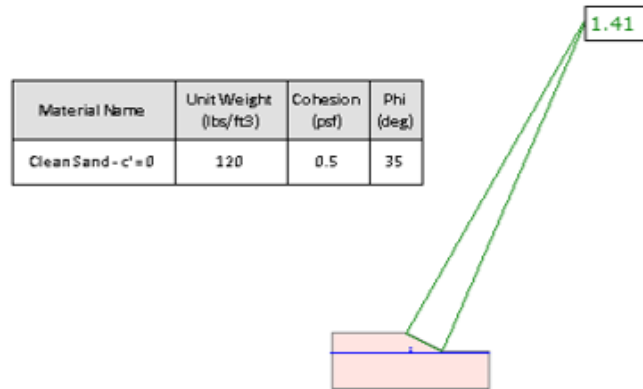
Sites with observed creep failure were more difficult to validate, because the output from SLIDE identifies the circular plane with the lowest resistance to sliding. Therefore, sites that exhibit only creep failure have a higher output FS, even when modeling a situation where failure was observed. Model outputs of slopes with low values of c' exhibited shallow failure surfaces. As mentioned earlier, infinite slope analysis was performed, and can be used to represent sites exhibiting creep failure. Figure 39 shows the SLIDE output of a site with low cohesion; the capacity of this site to resist creep failure was best represented by infinite slope analysis, as indicated by the very large failure radius.

Figure 39: SLIDE output with low c' , a site that is best represented by infinite slope analysis

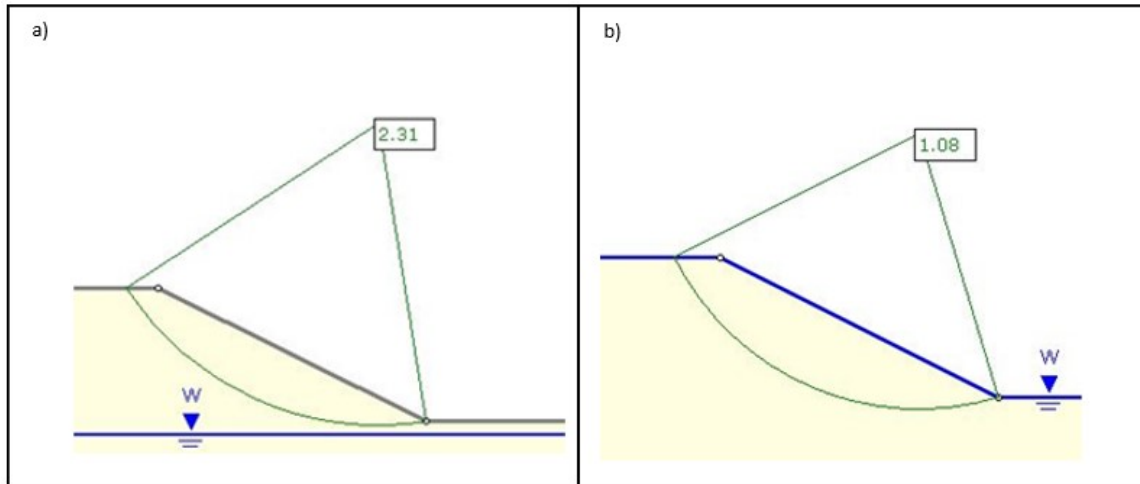
Groundwater has a negative effect on soil strength. This is a fundamental concept in soil mechanics; as pore water pressure (u) increases, effective stress (σ') decreases. Because σ' governs soil strength, an increase in pore water pressure decreases soil strength. Researchers modeled the effects of groundwater by considering a steady-state, worst-case scenario. Assuming all drainage features failed, the groundwater table would rise, and the phreatic surface would be the same as the ground surface. An example from the Murray County site is shown in Figure 40.

Figure 40: Groundwater effects, modeled by a) *in situ* and b) maximum, worst-case groundwater table heights

Installing drainage features returned the site to the hydrostatic conditions with a higher FS. Researchers did not consider transient groundwater analysis to represent a situation somewhere between the conditions shown in Figure 40. Any construction below the water table depth should involve detailed geotechnical analysis. These scenarios are outside the scope of the project.

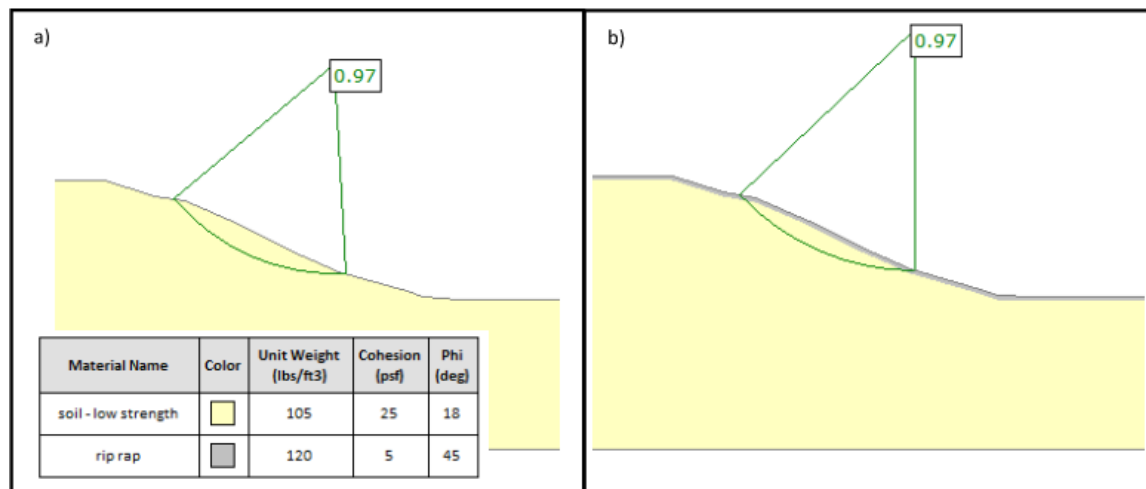
Surface cover does not typically increase the FS; in the case of rip rap cover, the method can increase weight and driving forces, which decreases the FS. Increasing strength properties of the cover material requires compaction, which can be difficult to achieve on the surface of a failing slope. Erosion protection is the main benefit, which is difficult to quantify and comes at the cost of increasing forces driving failure.

Figure 41: Example model a) with no surface cover, and b) with rip rap surface cover

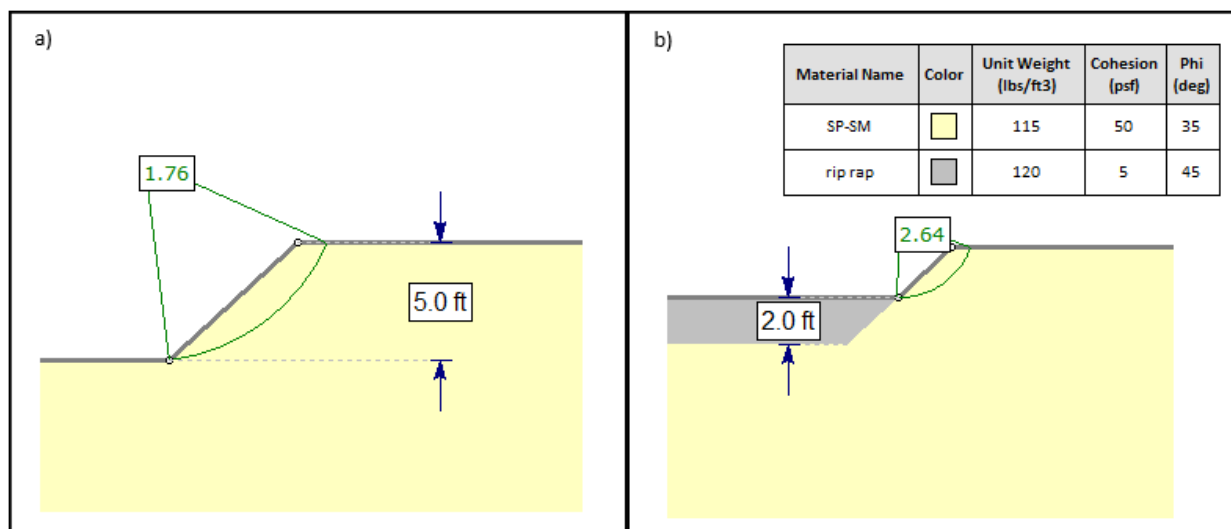
Researchers performed LEM tests on baseline slopes with buttresses extending various heights above the toe of the slope. An example from Lac Qui Parle County is shown in Figure 42.

Figure 42: Example model a) without and b) with buttressing

As Figure 42 illustrates, an aggregate buttress affects the failure surface. The buttress material has higher strength properties, so the failure occurs in the soil. Researchers noted the most benefit in small slopes. Buttressing does not appear to be as effective as other methods for most slopes.

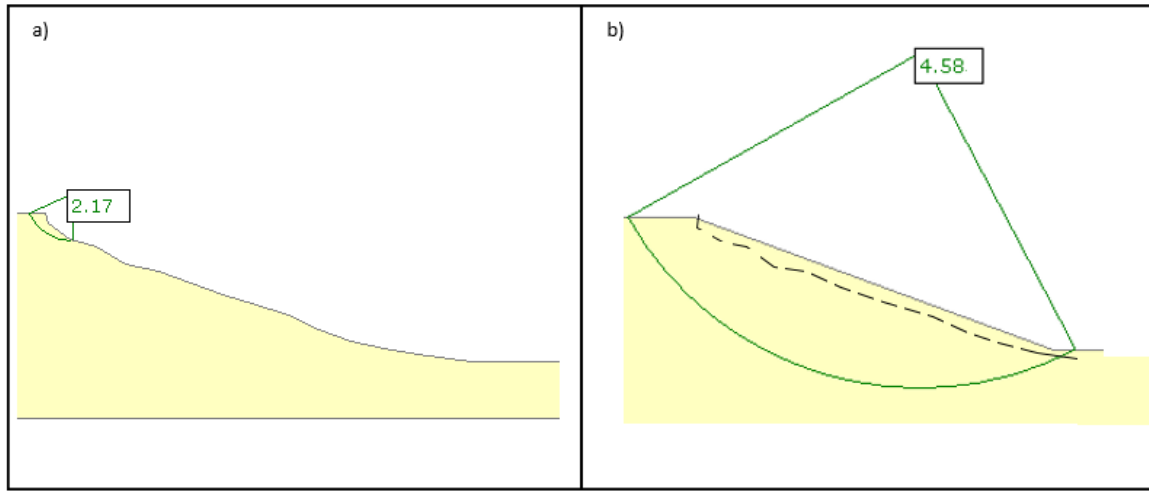
‘smoothing out’ irregularities. Shown in Figure 43, the overall FS at the Olmsted County site was noticeably improved by simply regrading the slope to the same overall angle.

Figure 43: Model of regrading and 'filling in' geometric inconsistencies; a) original and b) regraded

While the Olmsted County site is not a typical example, regrading typically improves stability. For every method that required excavation, researchers assumed the benefit of regrading, proper construction, and re-compacting. Similar to new construction, for reconstruction and excavation stabilization projects, the slope is finished at a specified grade. This ‘straight-line’ slope face avoided geometric inconsistencies encountered *in situ* and, therefore, outputs exhibited a higher FS. Re-compaction also increases strength properties. When comparing ‘before’ and ‘after’ models of failed slopes, researchers were able to model the material with higher strength parameters after regrading and re-compacting.

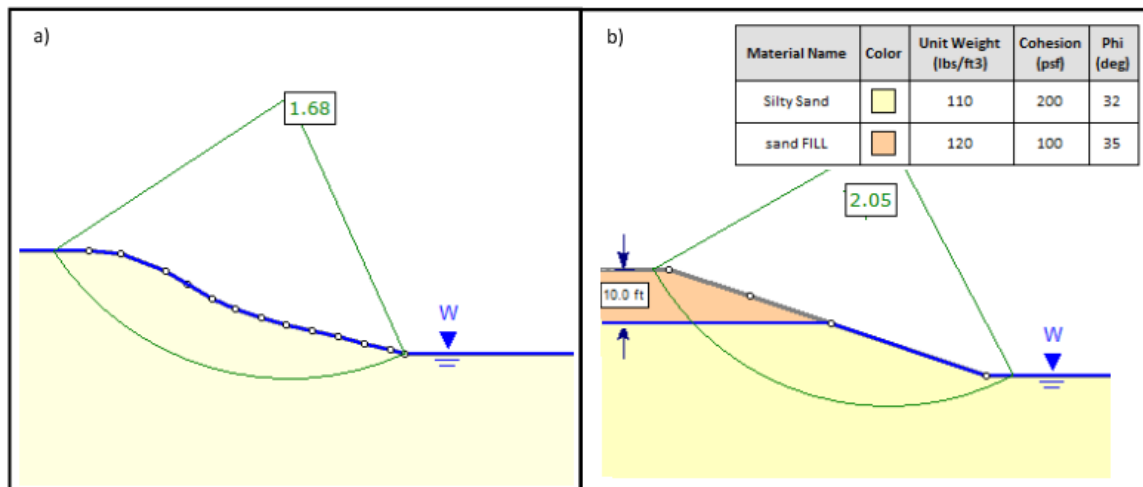
Figure 44: Example model of replacement with sand, worst-case drainage scenario; a) before and b) after replacement

The worst-case scenario in Figure 44 simulated poor drainage in the slope and replacing the top portion of the slope with free-draining fill. The adequate drainage scenario shown in Figure 45 represents

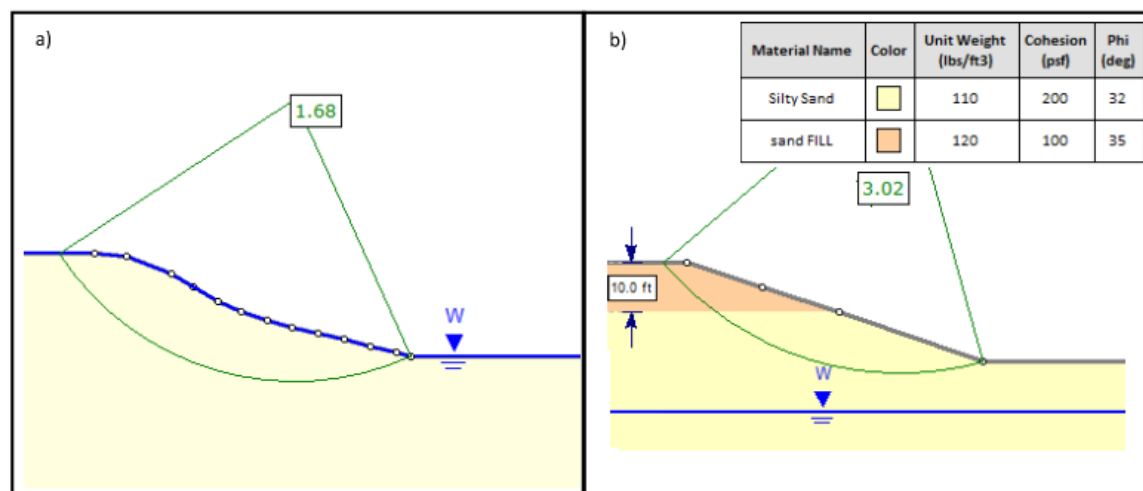
Figure 45: Example model of replacement with sand, adequate drainage scenario; a) before and b) after replacement and drainage feature installation

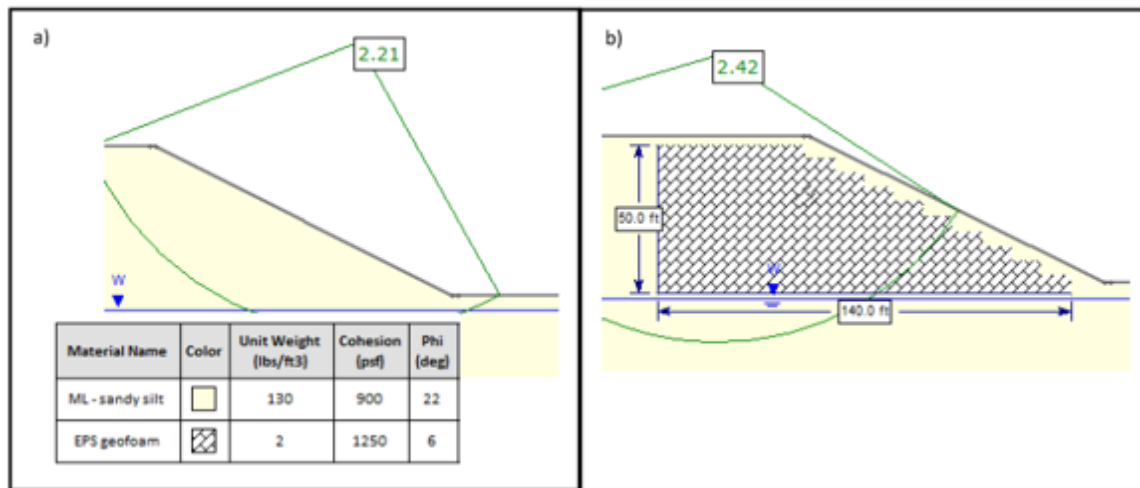
Researchers modeled scenarios which replace the entire slope depth with EPS geofoam to note the maximum difference in FS. An example of soil replacement with geofoam is shown in Figure 46.

Figure 46: Example model simulating a) before and b) after implementing EPS geofoam

Researchers noted little to no benefit from using geofoam on most slopes. The greatest benefit was on the largest, heaviest slopes, where excavation would cost the most. This method requires extra consideration in areas with environmental sensitivity concerns. Due to material buoyancy, geofoam should not be used in flood planes. The use of EPS geofoam also requires excavation, and is likely a better consideration during the design of new slopes.

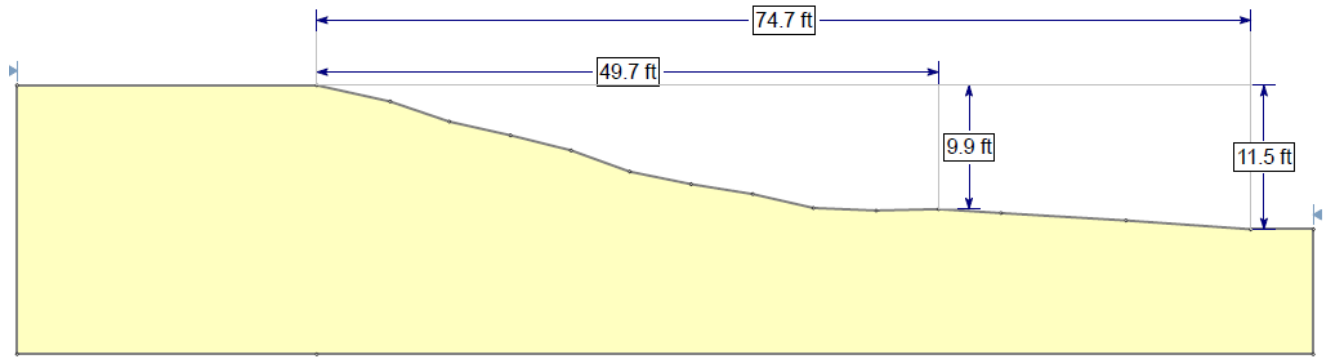
Figure B5-5: Koochiching County site cross section from failed zone

The observed failure at the Koochiching County site had a nearby indication of groundwater, and exhibited clear and persistent soil creep. The county representative mentioned that slopes exhibited new failures each spring. With groundwater present, and *in situ* material being frost-susceptible cohesive soil, frost heave is a likely cause of soil movement. Drainage features are the research team's main recommendation for slope stabilization. If creep is at the top of the slope, maintenance crews can also consider replacing the top portion of the slope with free-draining sand. This option would require excavation and the implied expenses. If the failure is near the bottom of the slope, a buttress can be an effective stabilization method, avoiding excavation costs.

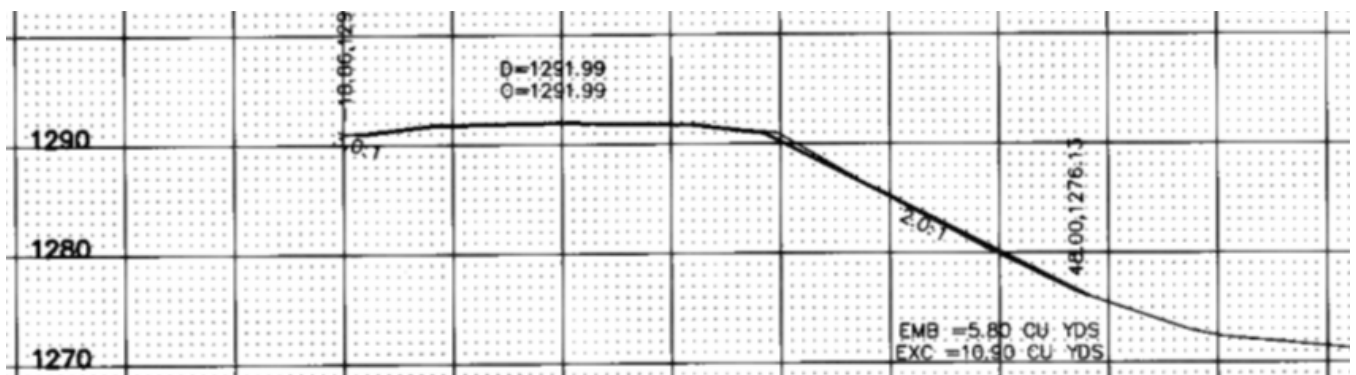
Figure B8-4: Murray County site geometry

At the Murray County Site, it is clear how soil creep at the top of a slope can lead to pavement damage. In the absence of groundwater, poor compaction decreases the soil's shear strength. Replacing the poor soil with properly-compacted fill is recommended to stop soil creep.

Site geometry was not measured, because the slope was reconstructed for repairs. Figure B8-4 shows a cross section from the reconstruction plans, provided by the county highway department:

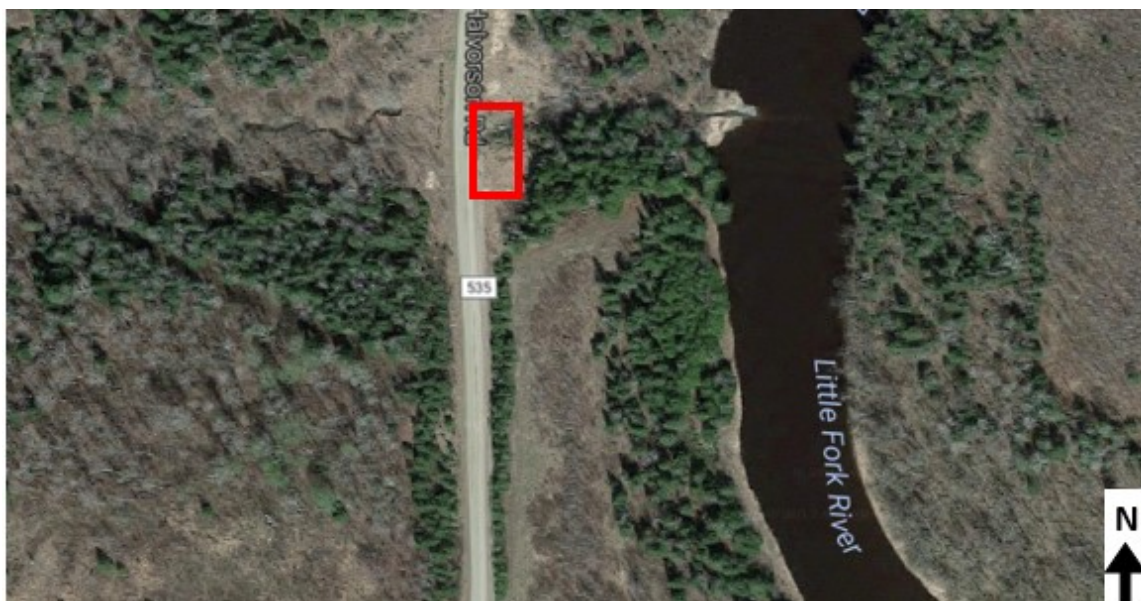
Figure B12-2: St. Louis County site location

The Littlefork River is located near the toe of the slope. A drainage culvert failure appears to be the cause of the failure. An aerial photo of the site is shown in Figure B12-2:

The site failure was severe, so researchers did not measure the slope profile. The site was eventually disregarded as a case study for in-house stabilization of common slope failures.

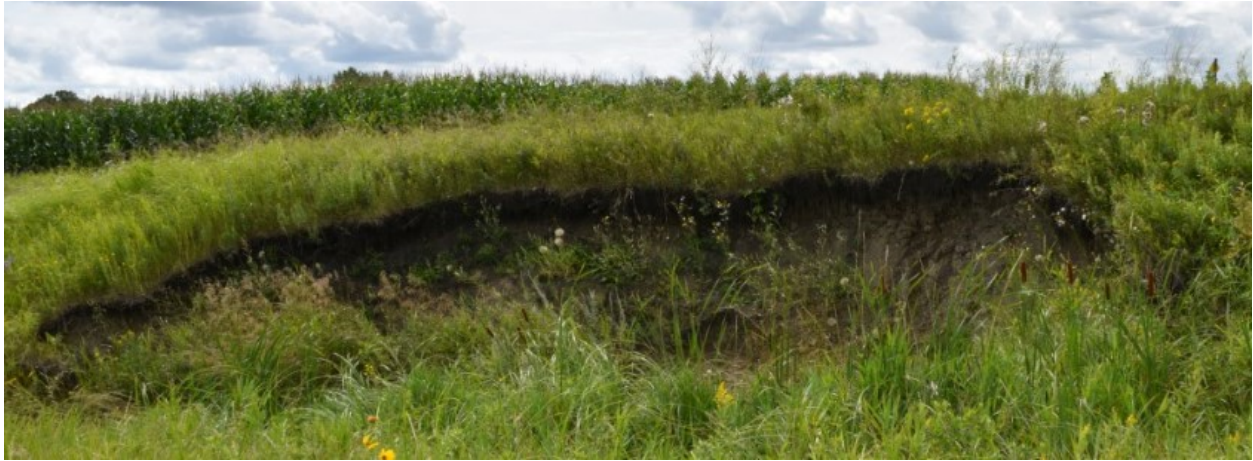
Scenario #1: Rotational failure, cohesive soil, poor drainage

Example of Scenario #1 (from Pennington Co. site)

- Rotational failure
- Cohesive soil
- Groundwater concerns

Remove-and-replace, adding drainage features and vegetative cover

Sites can be identified by visible rotational failure. Maintenance teams should consider either remove-and-replace or regrading with *in situ* soil, adding drainage features, and vegetative cover. Drainage features remove groundwater, and fill-and-regrade work adds stability. Drains should be placed near the toe of the slope. If significant rotational failure has already occurred, the slope will need to be rebuilt. Design teams should consider as low of a slope angle as possible.

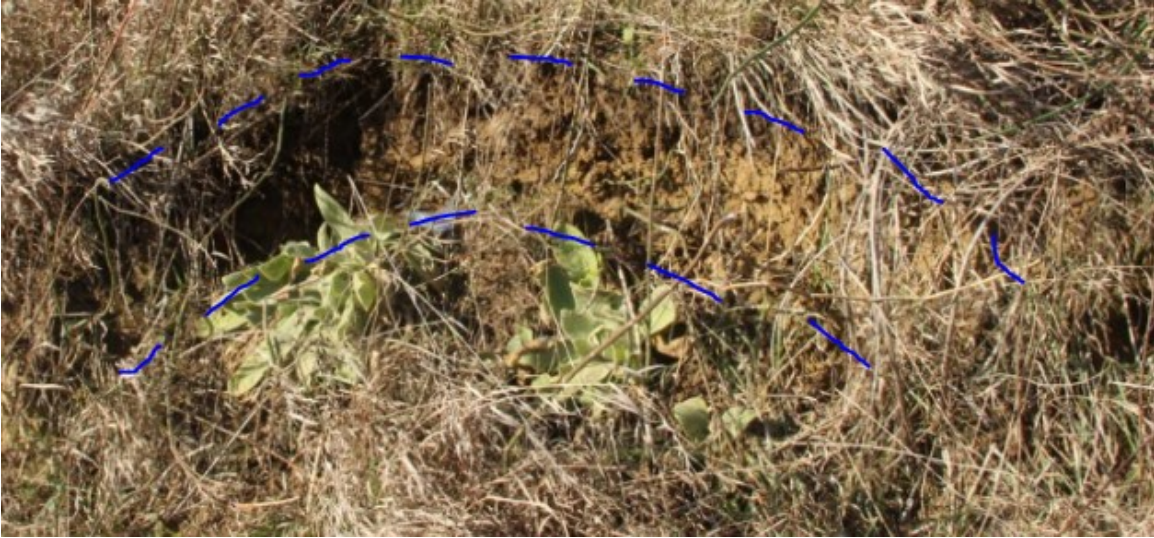
Scenario #2: Rotational failure, cohesive soil

Example of Scenario #2 (from Olmsted Co. site)

- Rotational failure
- Cohesive soil
- No groundwater concerns

Remove-and-replace, or regrade and re-compact, with vegetative cover

Failure can be identified by visual observation. Many factors can cause soil to lose strength other than groundwater effects, such as poor compaction. Regrading and re-compacting, when properly executed, increases soil strength and slope stability. Maintenance teams should evaluate the *in situ* soil properties, and either re-use the material, or use common borrow if native material has poor properties.

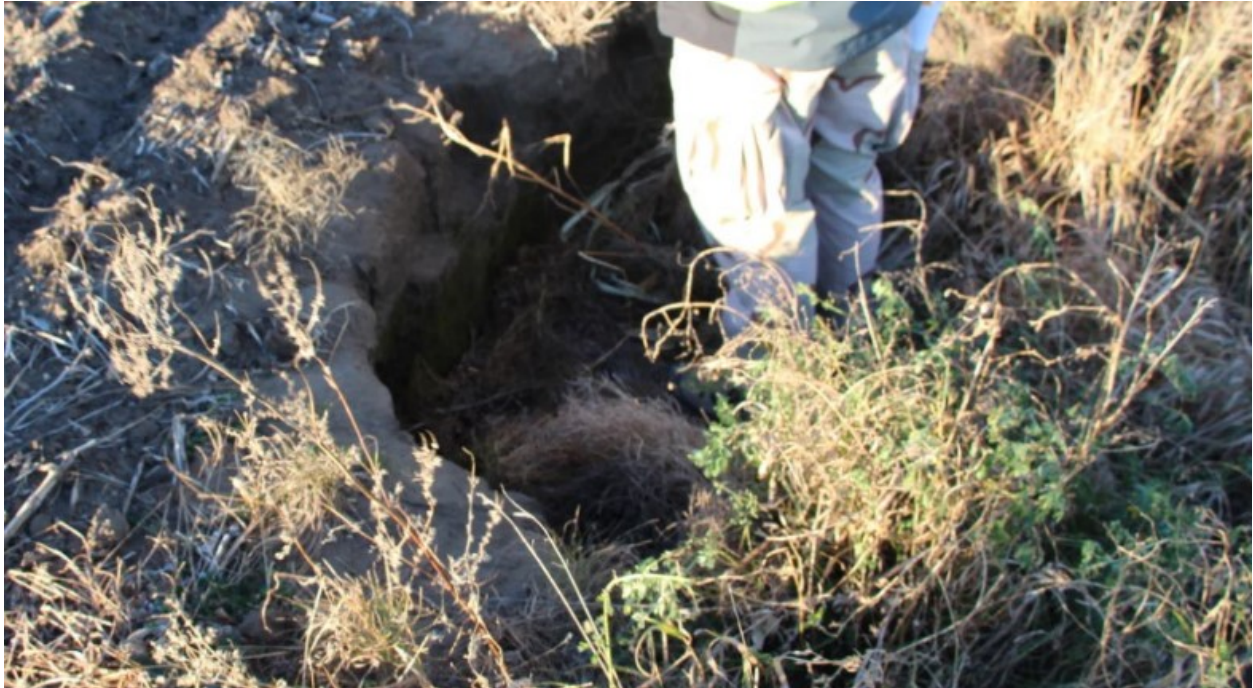
Scenario #4: Rotational failure, granular soil

Example of Scenario #4 (from Lac Qui Parle Co. site)

- Rotational failure
- Granular soil
- No groundwater concerns

Regrade and re-compact, with vegetative cover or more involved surface cover

Because groundwater is not the primary reason for failure, the main source of strength loss must be identified and mitigated. If erosion is evident, a more involved cover (i.e. rip rap or gravel) should be considered. Slope steepness may also be a concern. Researchers recommend regrading and compacting with *in situ* material. Extra consideration should be given to adequate ground cover to protect the slope from erosion damage.

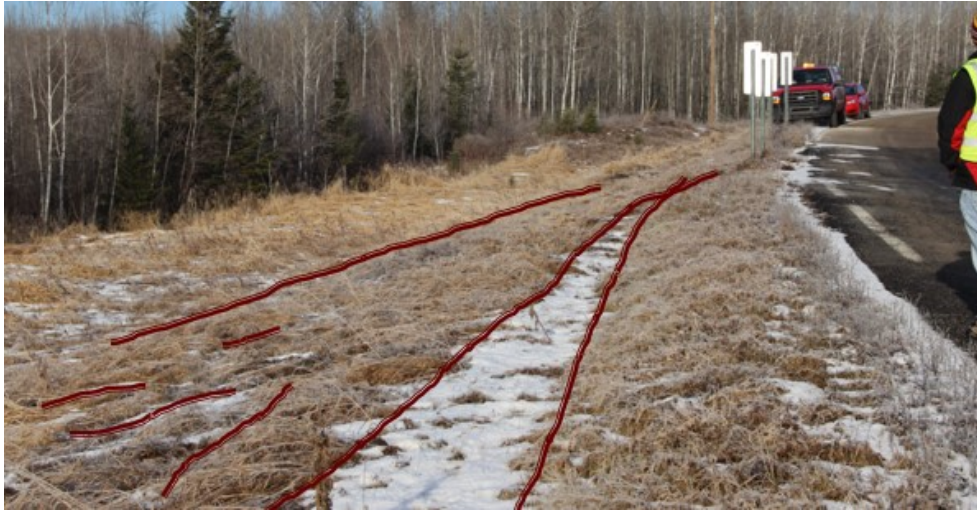
Scenario #5: Creep failure, cohesive soil, poor drainage

Example of Scenario #5 (from Koochiching Co. site)

- Creep failure
- Cohesive soil
- Groundwater concerns

Regrade and re-compact, with drainage features; if one area of failure, remove and replace.

A given site is more likely to have drainage concerns if cohesive material is present. Failure can be identified by crooked signs or trees, and leads to pavement damage. With groundwater present, and *in situ* material being frost-susceptible cohesive soil, frost heave is a possible cause of soil movement. Drainage features are the research team's main recommendation for slope stabilization. If creep is at the top of the slope, maintenance crews can also consider replacing the top portion of the slope with free-draining sand. If the failure is near the bottom of the slope, a buttress can be an effective stabilization method.

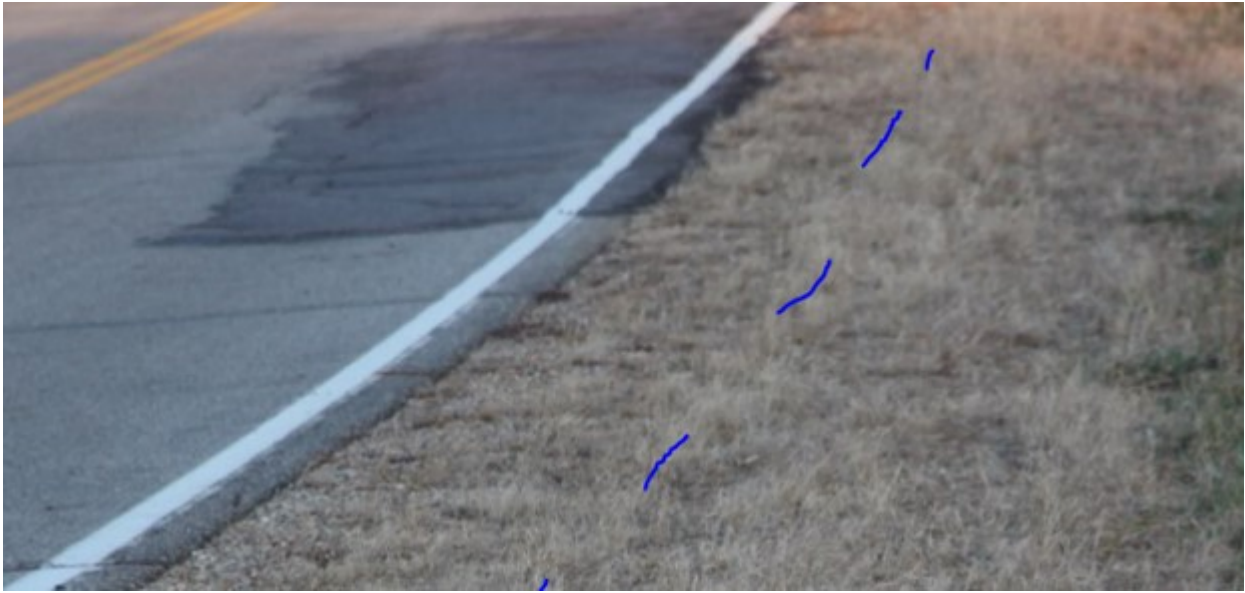
Scenario #6: Creep failure, cohesive soil

Example of Scenario #6 (from Murray Co. site)

- Creep failure
- Cohesive soil
- No groundwater concerns

Surface creep can be identified by bio-indicators like bent trees. The example clearly shows how soil creep at the top of a slope can lead to pavement damage. Replacing the failed portion of the slope with sand fill is the recommended option for increasing sliding resistance. In the absence of groundwater, poor compaction decreases the soil's shear strength. If *in situ* soil has adequate strength properties, regrading and re-compaction can be considered, but creep failure indicates concerns about strength of native material.

Remove, replace, and re-compact
